Limited Hazardous Materials Assessment

Salt Spring Island Firehall No. 1

105 Lower Ganges Road, Salt Spring Island, BC

Project No. 30875 HMA1 V1.0
Date issued: December 13th 2016

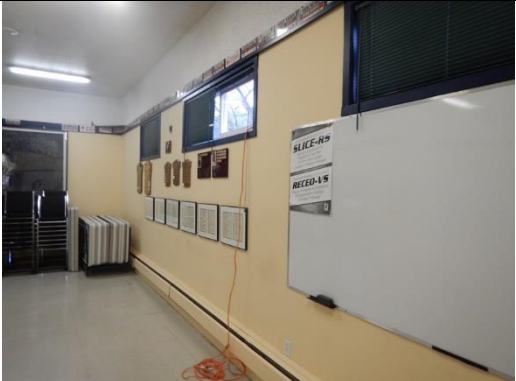
<p>Sample: 30875-05 Location: Truck Bay - Mezzanine Description: Drywall Joint Compound Hazardous Material: No Asbestos Detected</p>	<p>Sample: 30875-06 Location: Truck Bay – Mezzanine Column Description: Drywall Joint Compound Hazardous Material: Chrysotile Asbestos 1.8%</p>

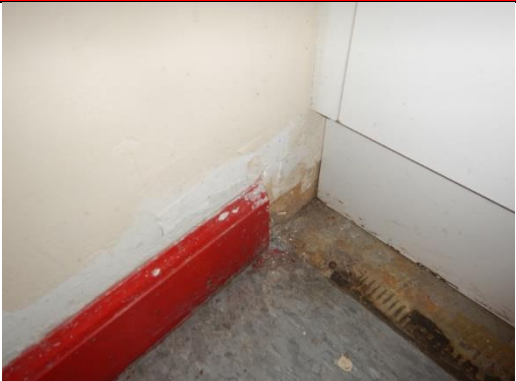
<p>Sample: 30875-07 Location: Office Area – Exterior Wall Description: Drywall Joint Compound Hazardous Material: No Asbestos Detected</p>	<p>Sample: 30875-08 Location: Training Room Description: Drywall Joint Compound Hazardous Material: Chrysotile Asbestos 2.4%</p>

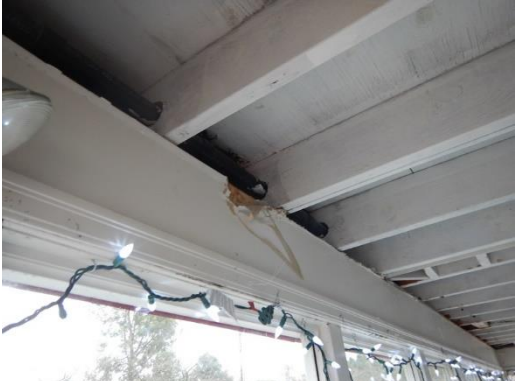
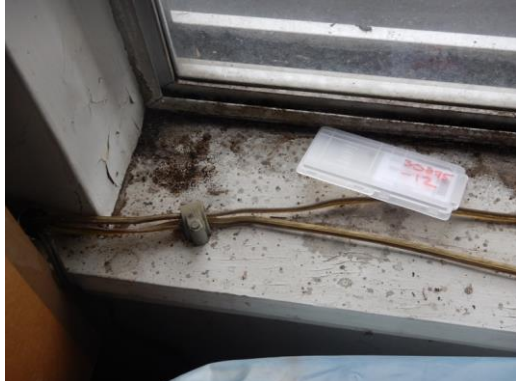
<p>Sample: 30875-09 Location: Trustee’s Room Description: Drywall Joint Compound Hazardous Material: Chrysotile Asbestos 2.5%</p>	<p>Sample: 30875-10 Location: Lounge Description: Drywall Joint Compound Hazardous Material: None Detected</p>

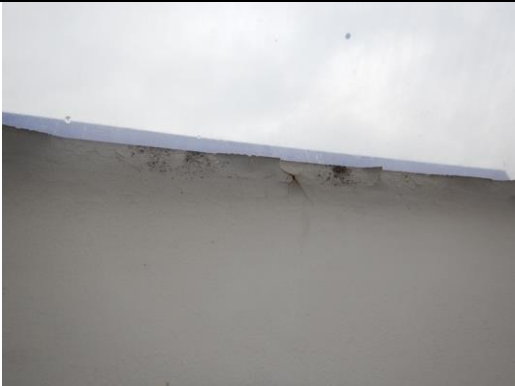
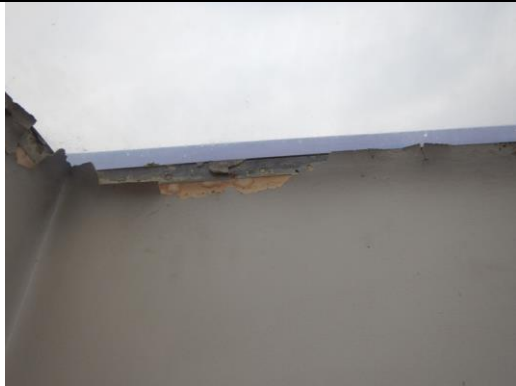
<p>Sample: 30875-11 Location: Display Room Description: Drywall Joint Compound Hazardous Material: No asbestos detected.</p>	<p>Sample: 30875-12 Location: Truck Bay Mezzanine Description: Tape Lift Mould: None detected</p>
